EVALUATION OF THE ABATTOIR'S OPERATIONAL INFRASTRUCTURE AND SANITATION PROCEDURES IN KANO STATE, NIGERIA

Zainab Sani Ali¹, Maimuna Sidi Muhammad², Datti Sani³,
Abdulsalam Mustapha⁴, Dr. Vijay Arputharaj J⁵,
Dr. A. SenthilKumar⁶, Dr. Sanjoy Kumar Pal^{7*}

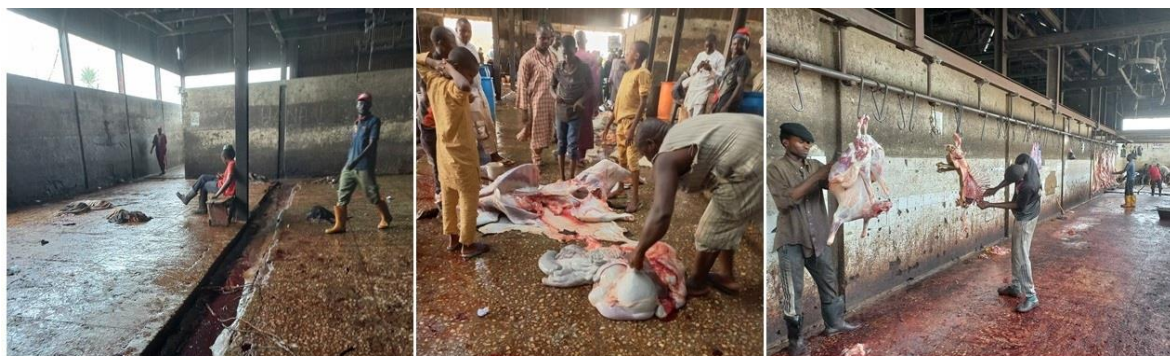
Sanitary practices in the abattoir were not as per the international standard. The abattoir did not have a sanitary section (table -2). The hygienic procedures were carried out manually using a wheelbarrow, disinfectants, water, and brooms. The solid wastes generated daily were dumping on vacant land and used in landfill. Liquid wastes disposal was done manually with brooms into the drainage system which was then routed into a nearby stream. The wastewater and its effluents such as gut contents, blood and urine etc., are directed into the drainage. After each slaughtering session, the grounds, slabs, and floor of the slaughterhouse are cleaned and sanitized (Figure - 1).

Figure 1 - Slaughtering of animals inside the Kano abattoir

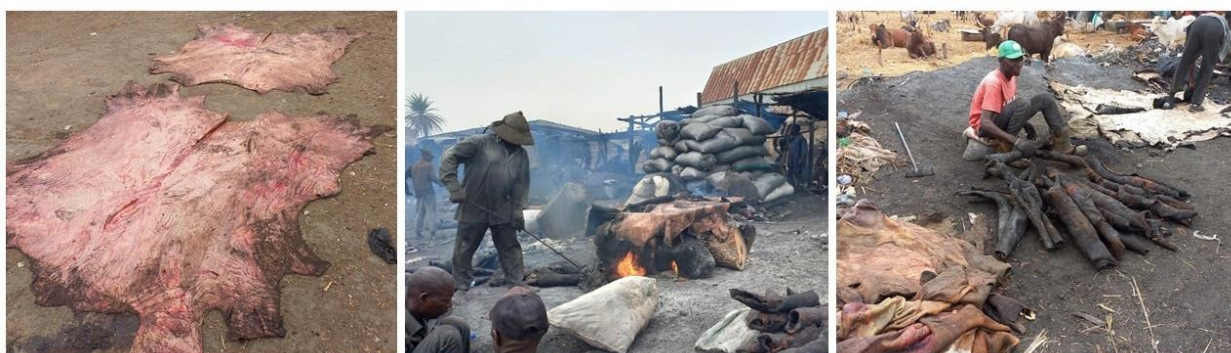
Roasted cowhide preparation known as 'Ponmo' or 'Ganda' is very popular in Nigeria. The skin of the animal is first washed, dehaired, partially dried in sun and then processed over flame. The entire process of Ponmo making that was carried out at the Kano abattoir premises was studied. The flame for the fire was

generated by burning wood logs and coal (Figure - 2). The operating condition was not very hygienic in which Ponmo was made, the entire place is full of coal dust, smoke and littered with waste. Huge quantity of blood that are collected from slaughtered animals are sold to poultry feed manufacturers. The hooves and horns of animals are sold to the local vendors.

Figure 2 - Burning of cattle skin for making of Ponmo
